NEOTECTONICS, LANDSLIDES AND PLANNING:

The Case of Maratea (PZ),

Basilicata, Southern Italy

Thesis presented for the degree of Doctor of Philosophy

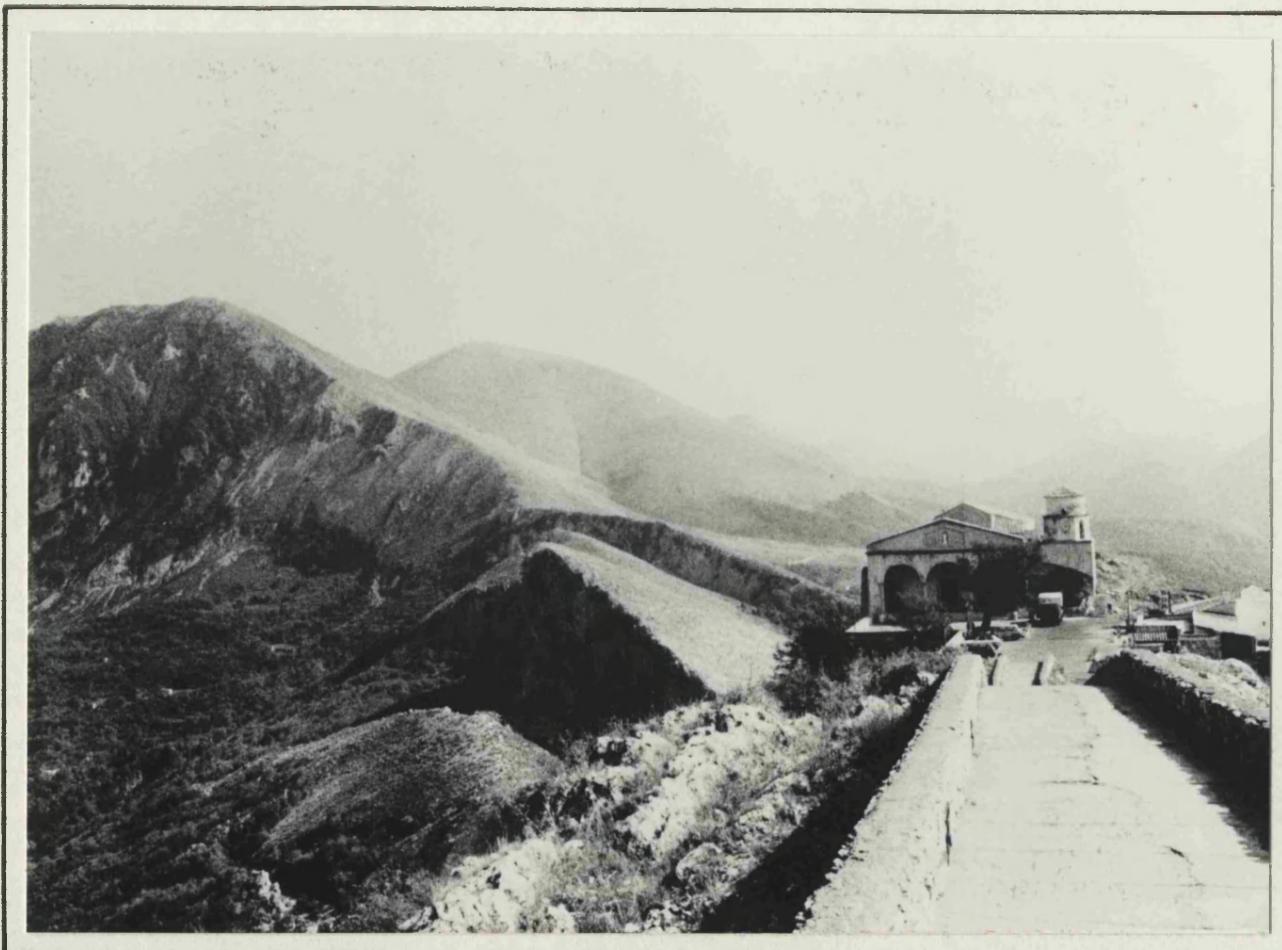
Frontispiece: The sackung deformation on the summit of Monte San Biagio, Maratea, southern Italy.

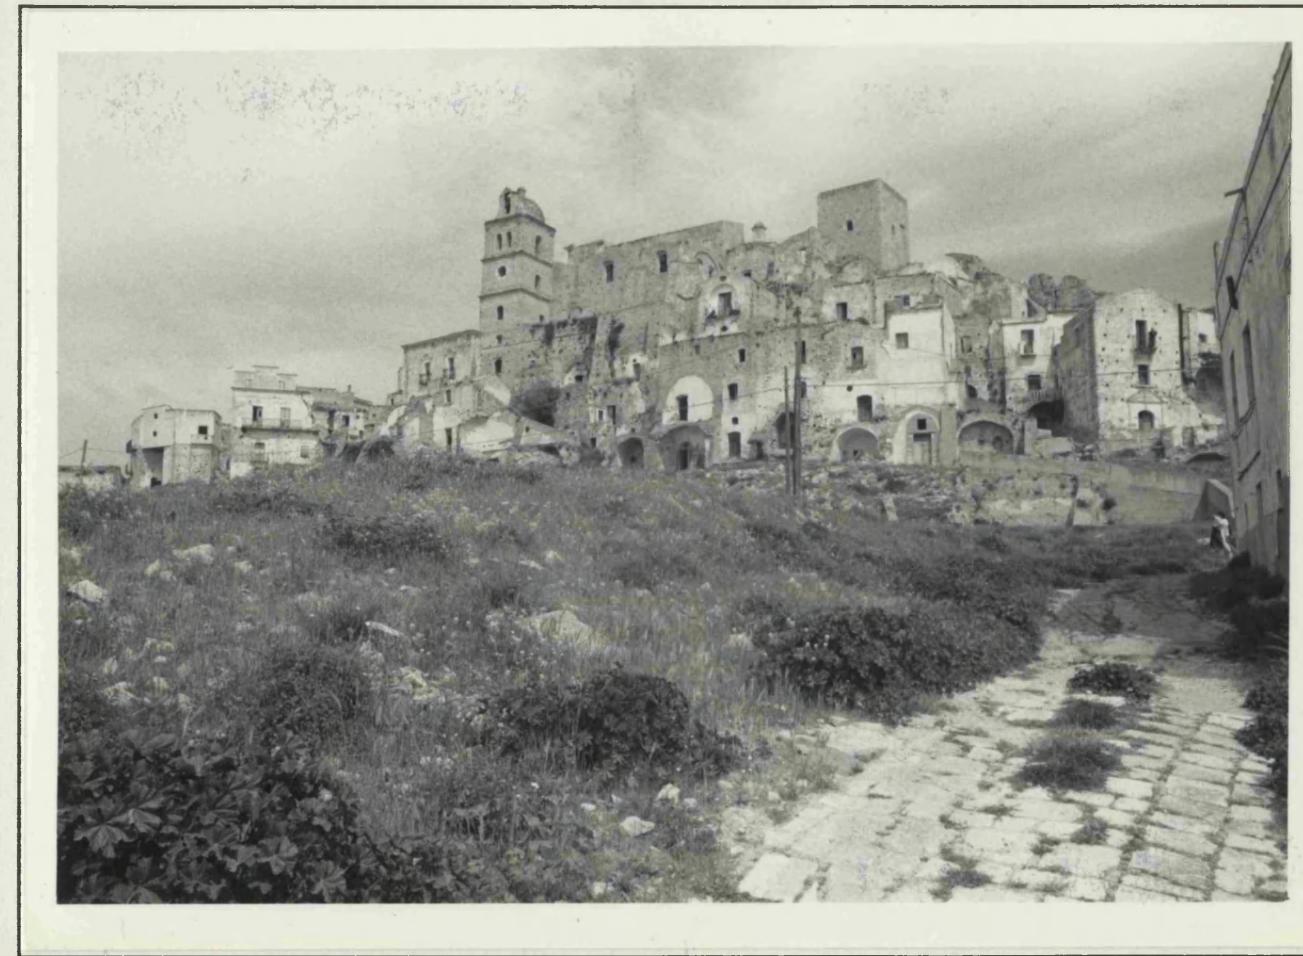
Plate 1.3: The village of Craco in Matera Province, now abandoned because of massive landsliding.

Resiting landslide prone villages is the most obvious answer to the problem; reducing vulnerability by moving away from areas of potential hazard. Yet, attempts to do so have been singularly unsuccessful. Craco (MT) which, as noted above, was virtually destroyed by landslides in 1966 was rebuilt as Stazione Craco in a nearby valley location. The new town is tremendously unpopular with its inhabitants, lacking the traditional feel and architecture of the old town. Indeed, so unpopular is this new town that the old Craco is still home to a few dozen people. Similarly, Bisaccia, a town in the Avellino province of Campania, has suffered damage throughout its history from three active landslide zones, to the point where 1,000 homes are now uninhabitable. Despite this the Bisaccia Structure Plan which recommended abandonment and a new safer site, met with enormous

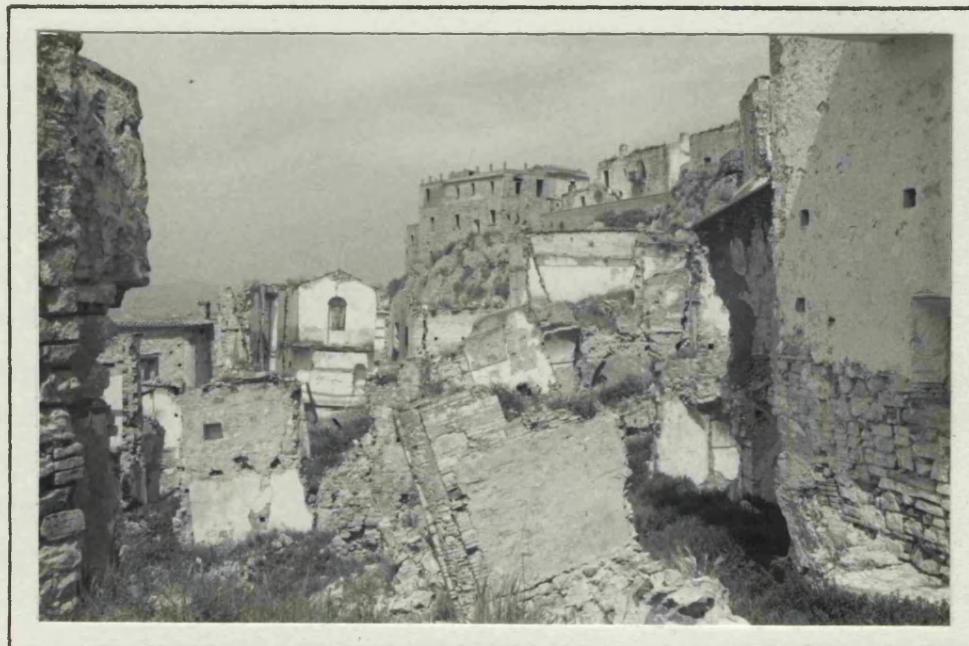
Plate 1.4: Landslide damage to Craco (MT).

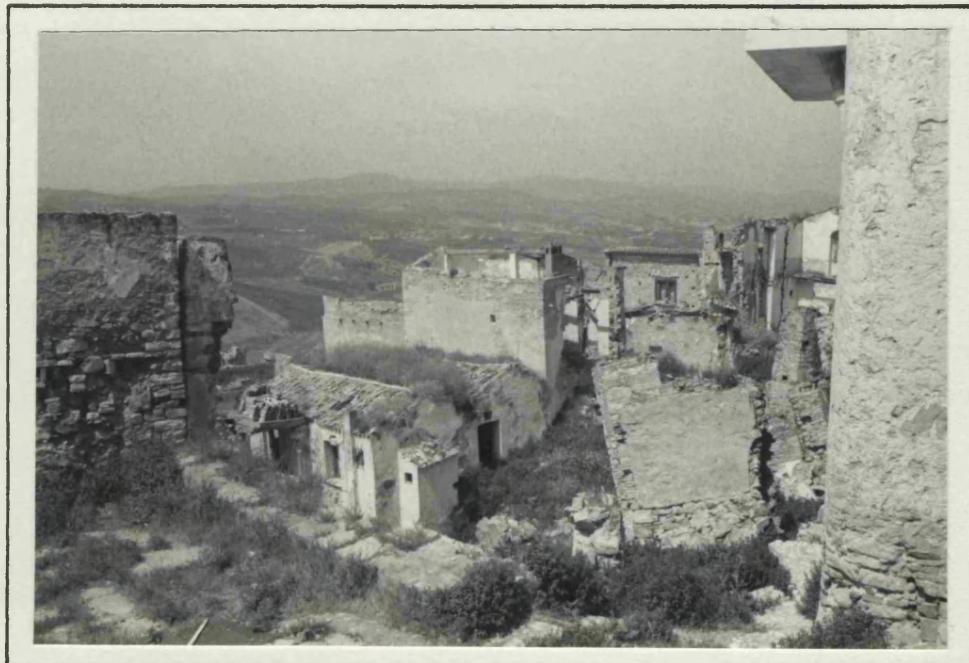
Plate 1.5: Landslide damage to Craco (MT).

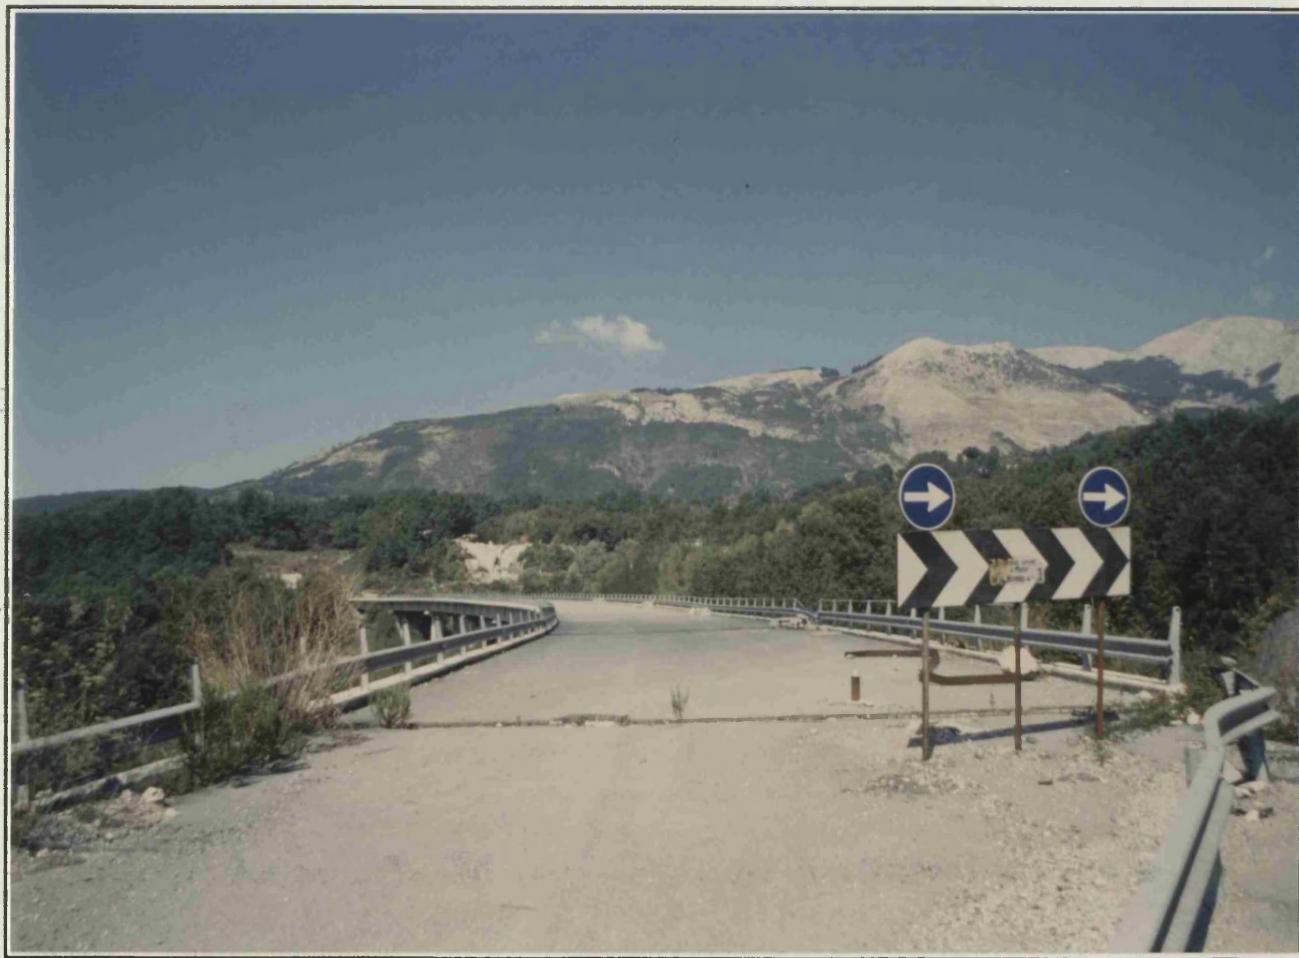
Plate 1.6: Viaduct on the S.S. 92 abandoned due to a rotational landslide. The road was funded by the Cassa per il Mezzogiorno

Damage to roads from landsliding is also a serious and recurring problem in the Mezzogiorno. Alexander (1981) reports that virtually all of the 29 state roads (strada statali or SS) exposed to serious seismic shaking in the 1980 earthquake were damaged due to landslide activity. In addition, the main Salerno - Potenza road (the Basentana) was damaged due to rockfalls and shallow sliding movements. Fortunately few major roads traversed the area of greatest earthquake intensity and damage was limited. Nonetheless, the infrastructure network in the Mezzogiorno has been the recipient of a great deal of funding both from the Cassa and the E.E.C. and many roads are very high cost capital, projects; the Basentana, for example, could only be built with major funding from the Cassa as it requires major viaducts and tunnels along its route. Setting aside the actual traffic use which these roads get, which in many instances does not justify the cost, it is regrettable that a number of them will always require expensive remedial work because they cross landslide zones that were not identified before construction began. A notable exception was the work of Baldassare and Radina (1980) who investigated stability conditions along the length of the SS 92 running between the towns of San Arcangelo and Senise. Regretfully their findings, largely based on geotechnical observations, only recommended viaducts, cuttings, embankments and defensive works; no attention was apparently paid to road realignment to avoid potential landslide zones. As a result many expensive viaducts along the SS 92 are now suffering considerable distress due to slope failures (Plate 1.6).

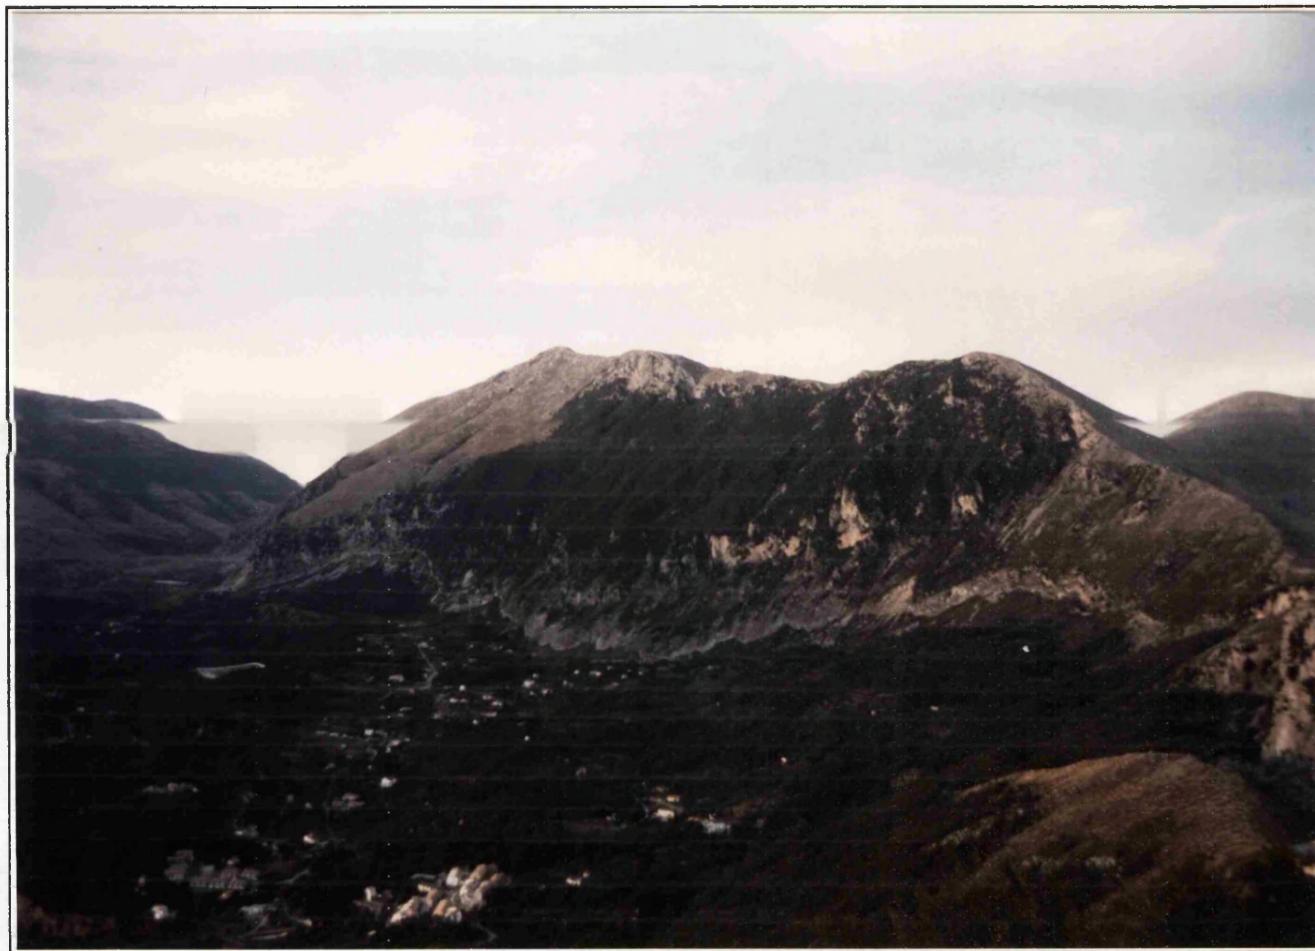
Plate 1.9: Major structural features of the Maratea valley. The fault plane scarp is a clear light coloured band under Monte San Biagio. The sackung is on the extreme right and the limestone block field, is the heavily vegetated area below the fault.

The valley of Maratea has three major visible structural features noted in section 1.5.1. These are (see Plate 1.9):

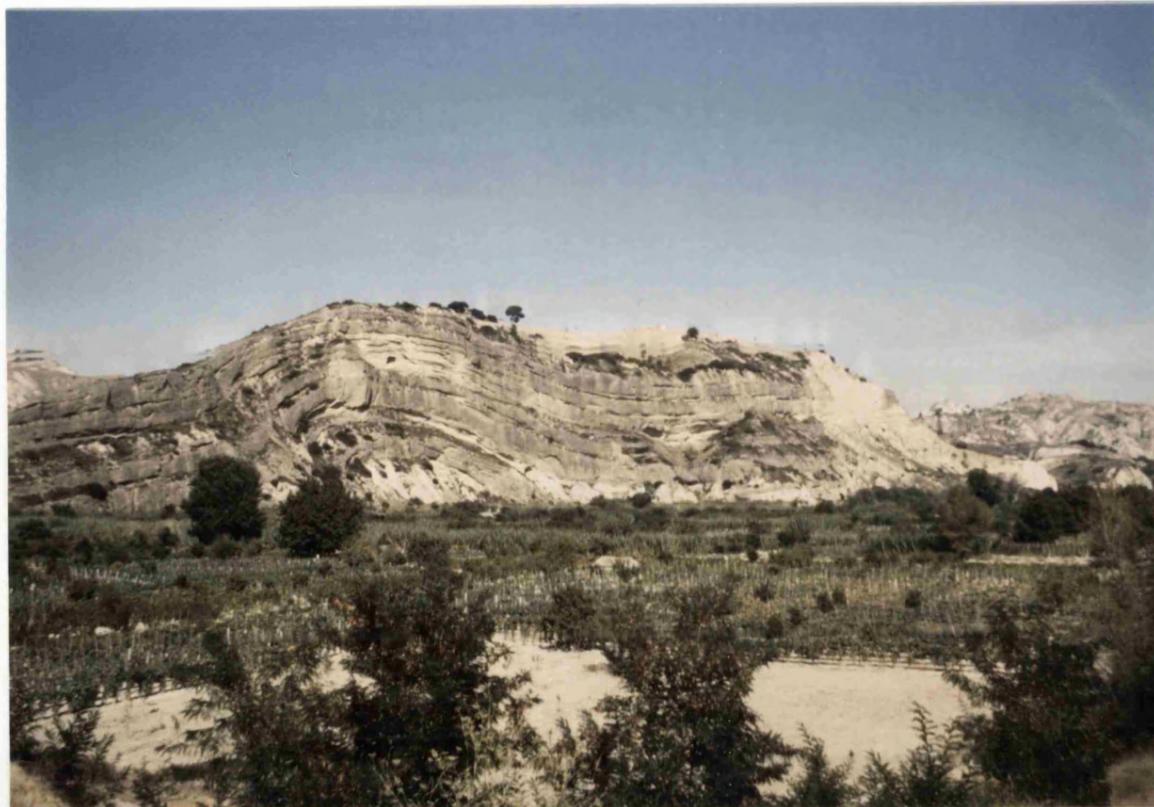
Plate 2.1: Nappe structure in well consolidated Plio-Pleistocene sandstones near Aliano

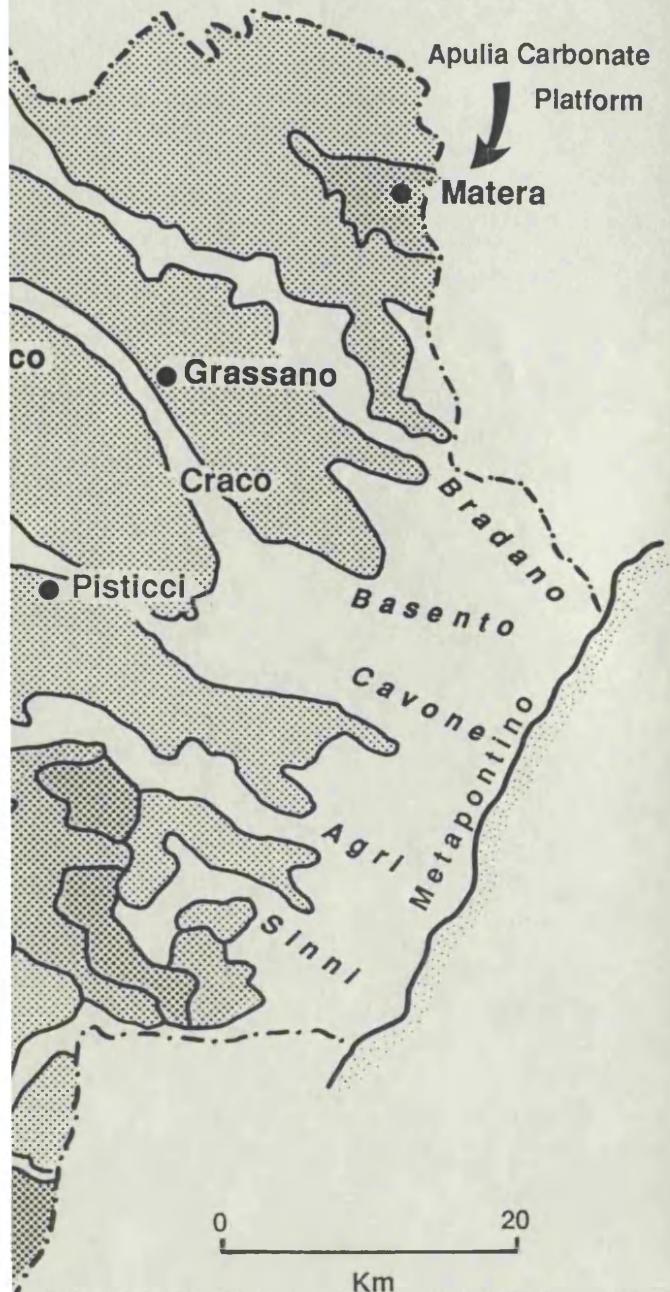
Fig. 2.4: Generalised relief map of Basilicata

0 - 200	River Valleys
200 - 400	Plio-Pleistocene Deposits
400 - 800	Hills of Potenza
800 - 1000	Lucanian Dolomites
1000 - 1200	M.Vulture Volcanics and Limestone Mountains of Western Basilicata
>1200

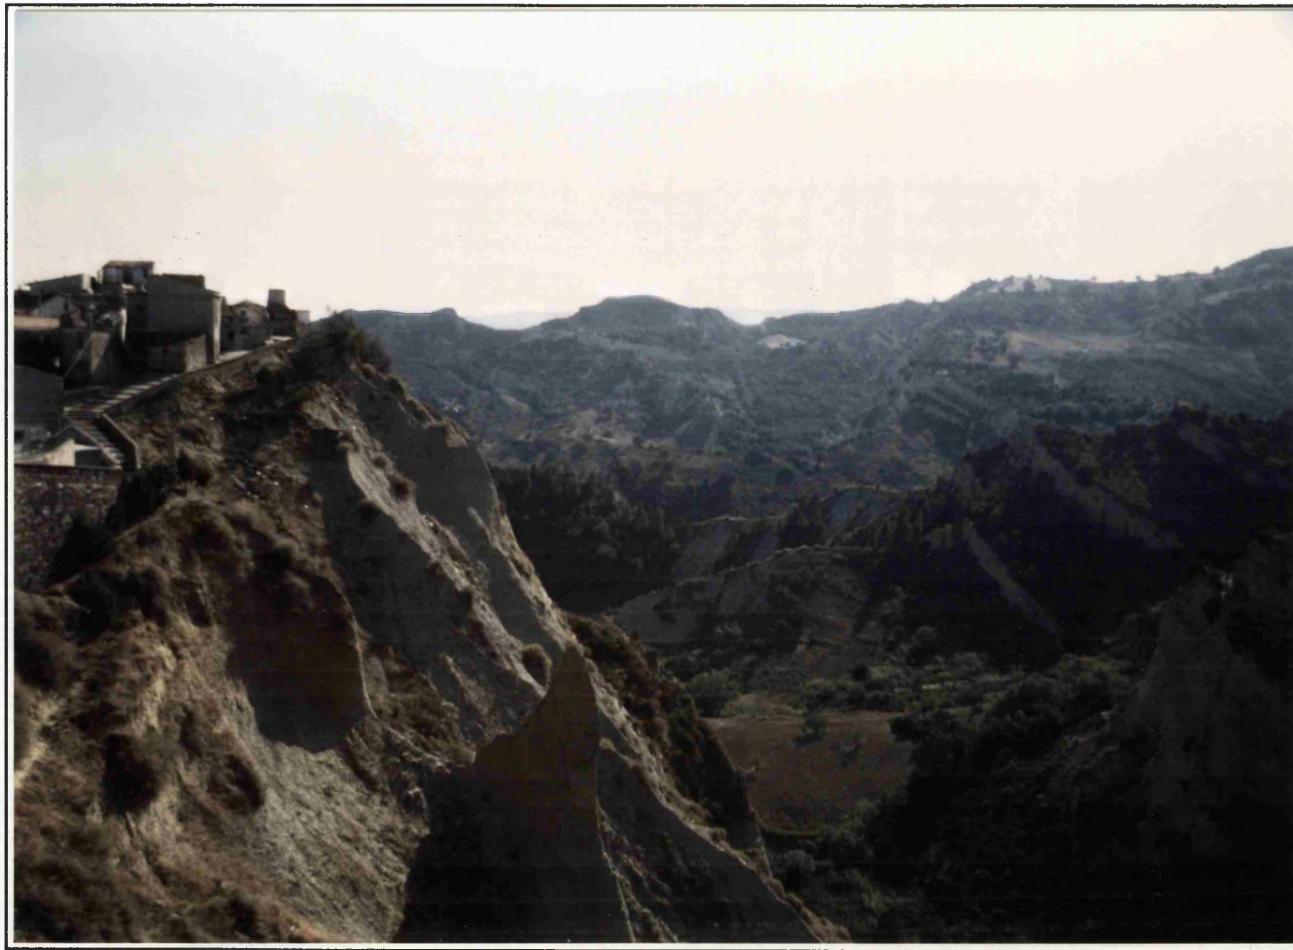
Plate 2.2: Plio-Pleistocene deposits of eastern Basilicata. The town is Alianello seen from Aliano - the two are separated by the landslide in the centre of the photograph.

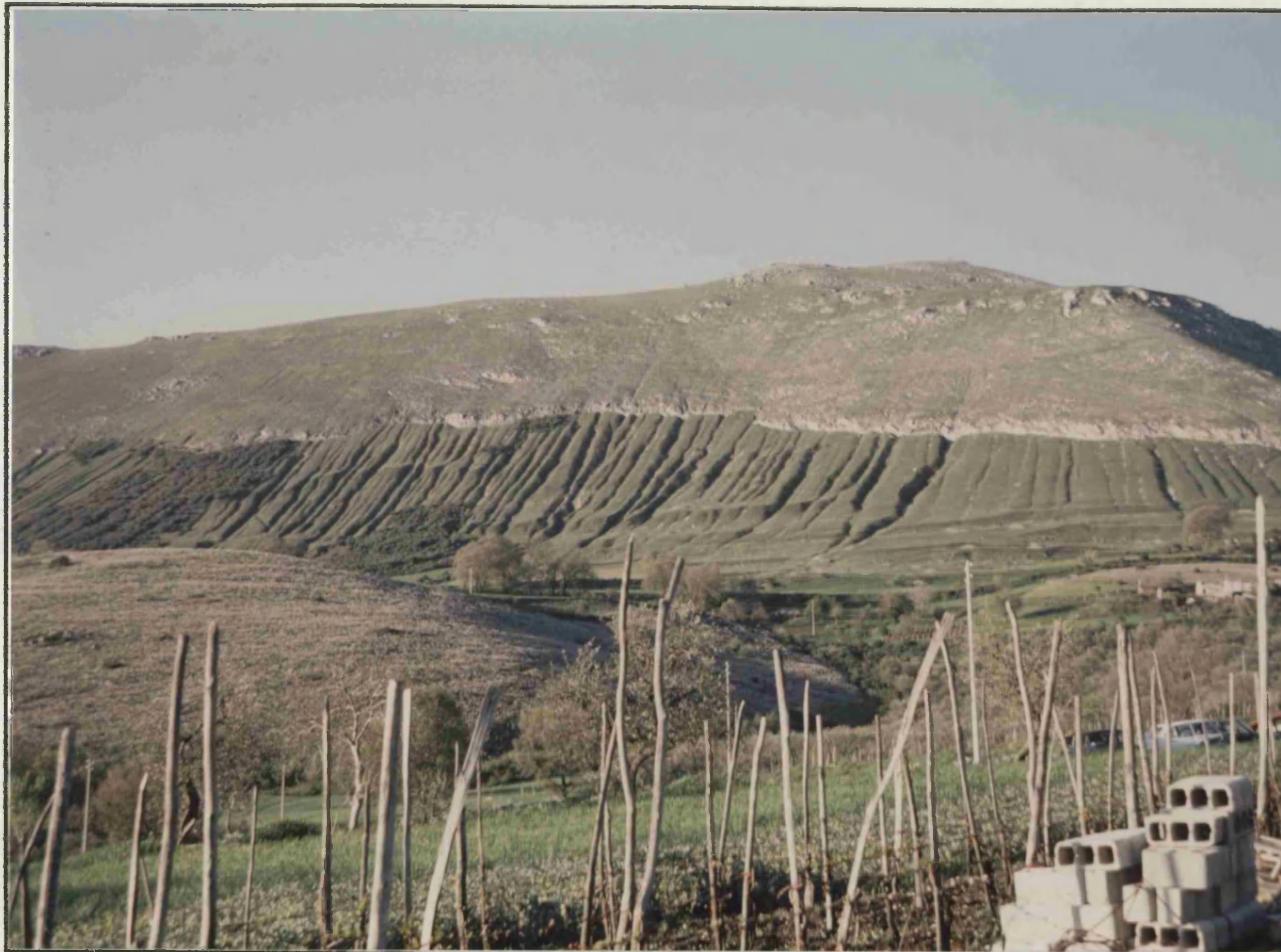
Plate 2.6: Thrust fault near Marsico Vetere in western Basilicata.

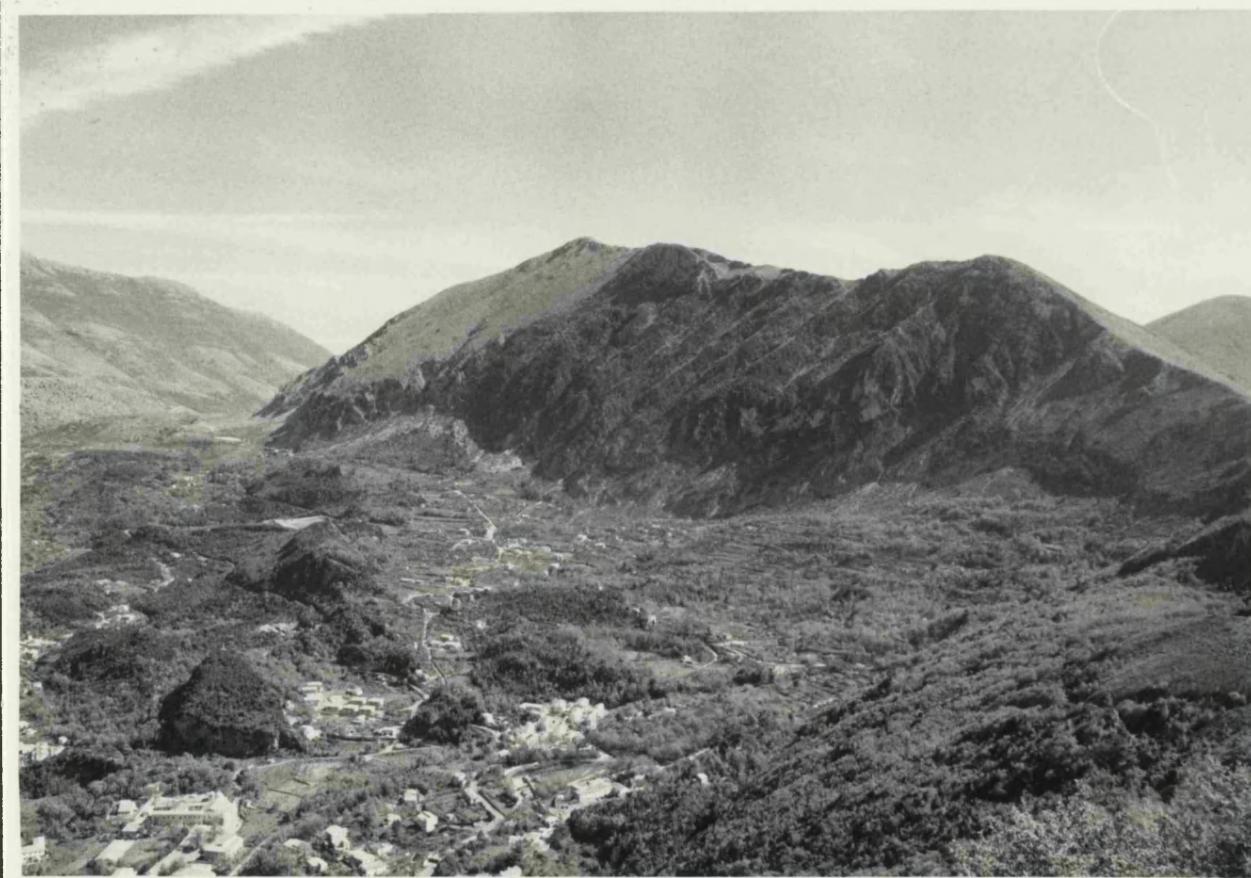
Plate 2.7: The Maratea valley on the western coast of Basilicata. The summit of Monte Crivo is in the centre of the photograph. One of the normal faults can be seen at the base of the mountain.

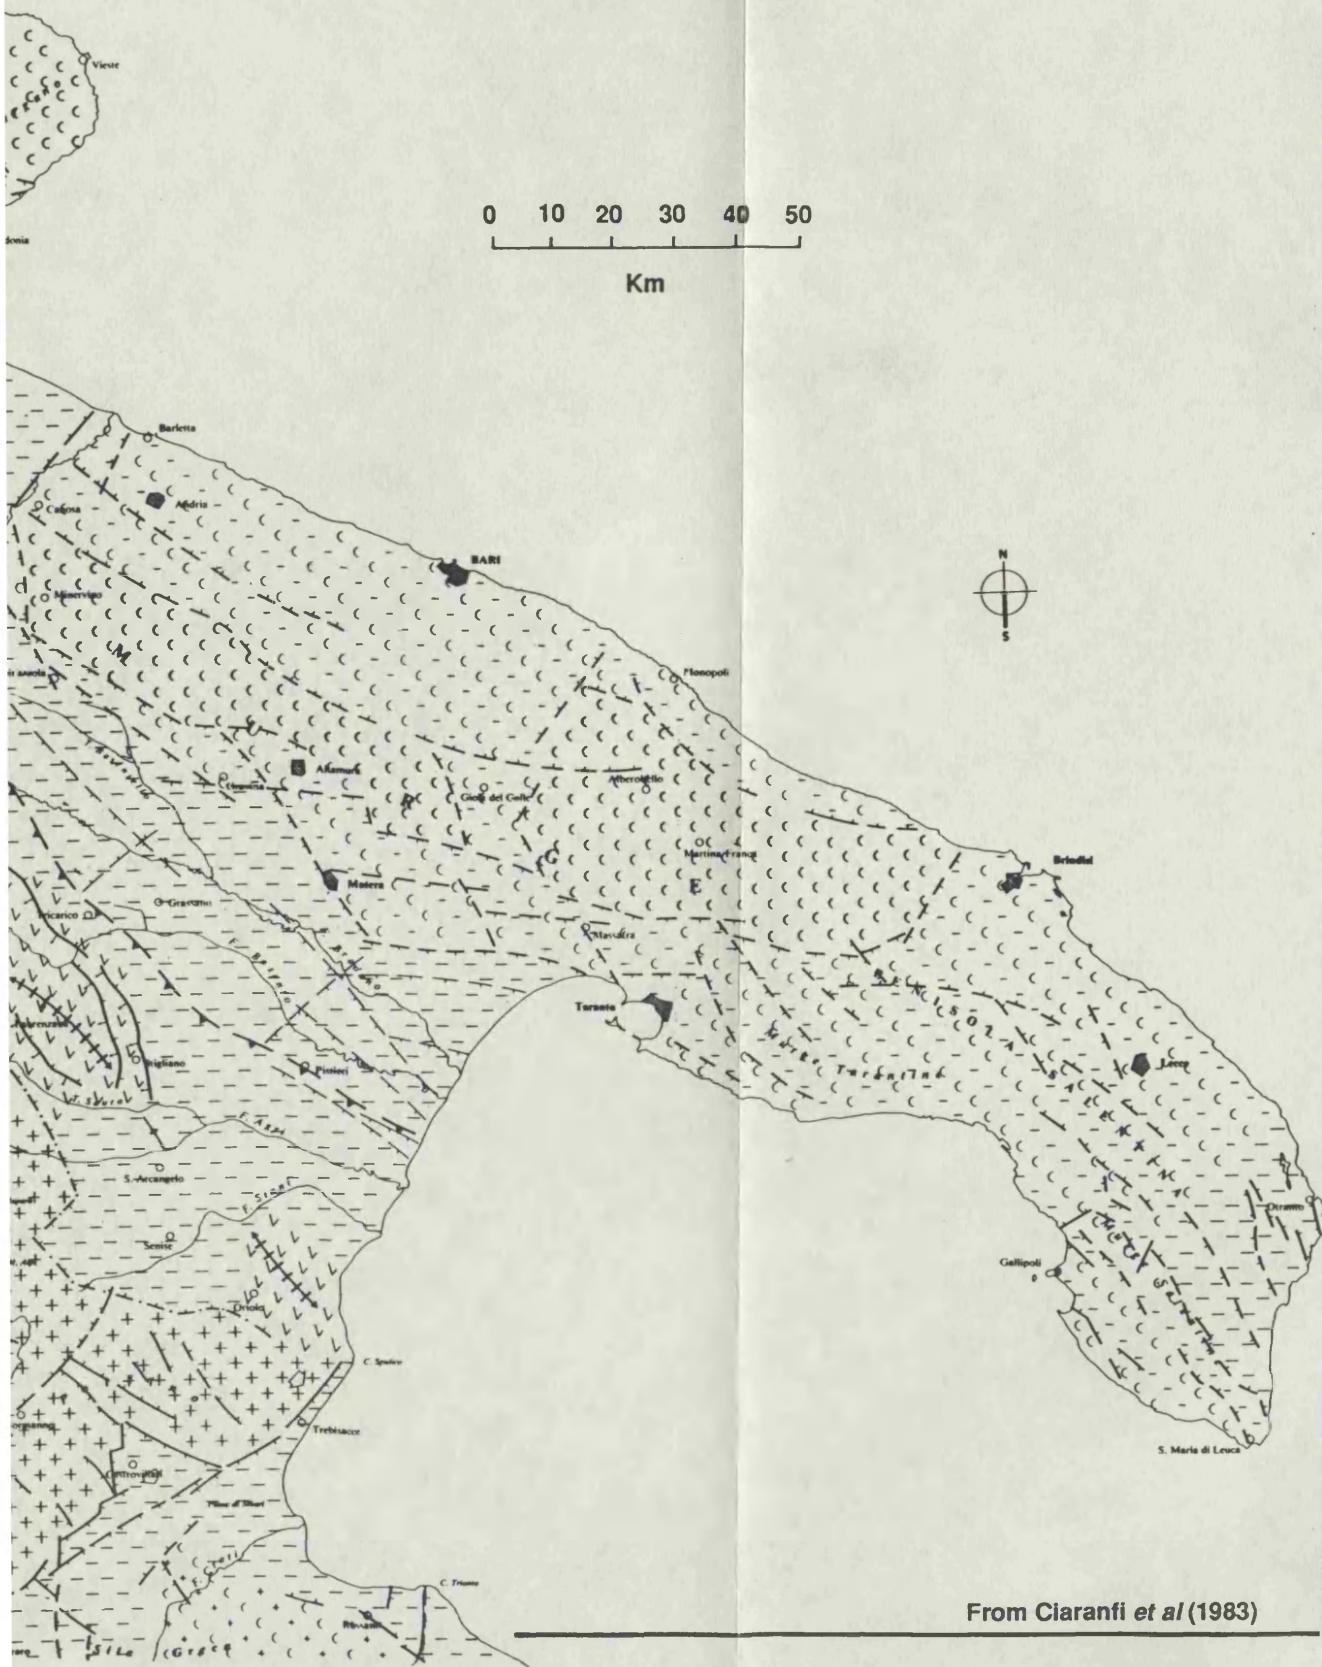
Fig. 2.5b: Neotectonic evolution of southern Italy - Interval IIIa

3.8/3.5MY - 2.0MY BP

- **Interval IIIa (See Fig. 2.5b and Legend)**

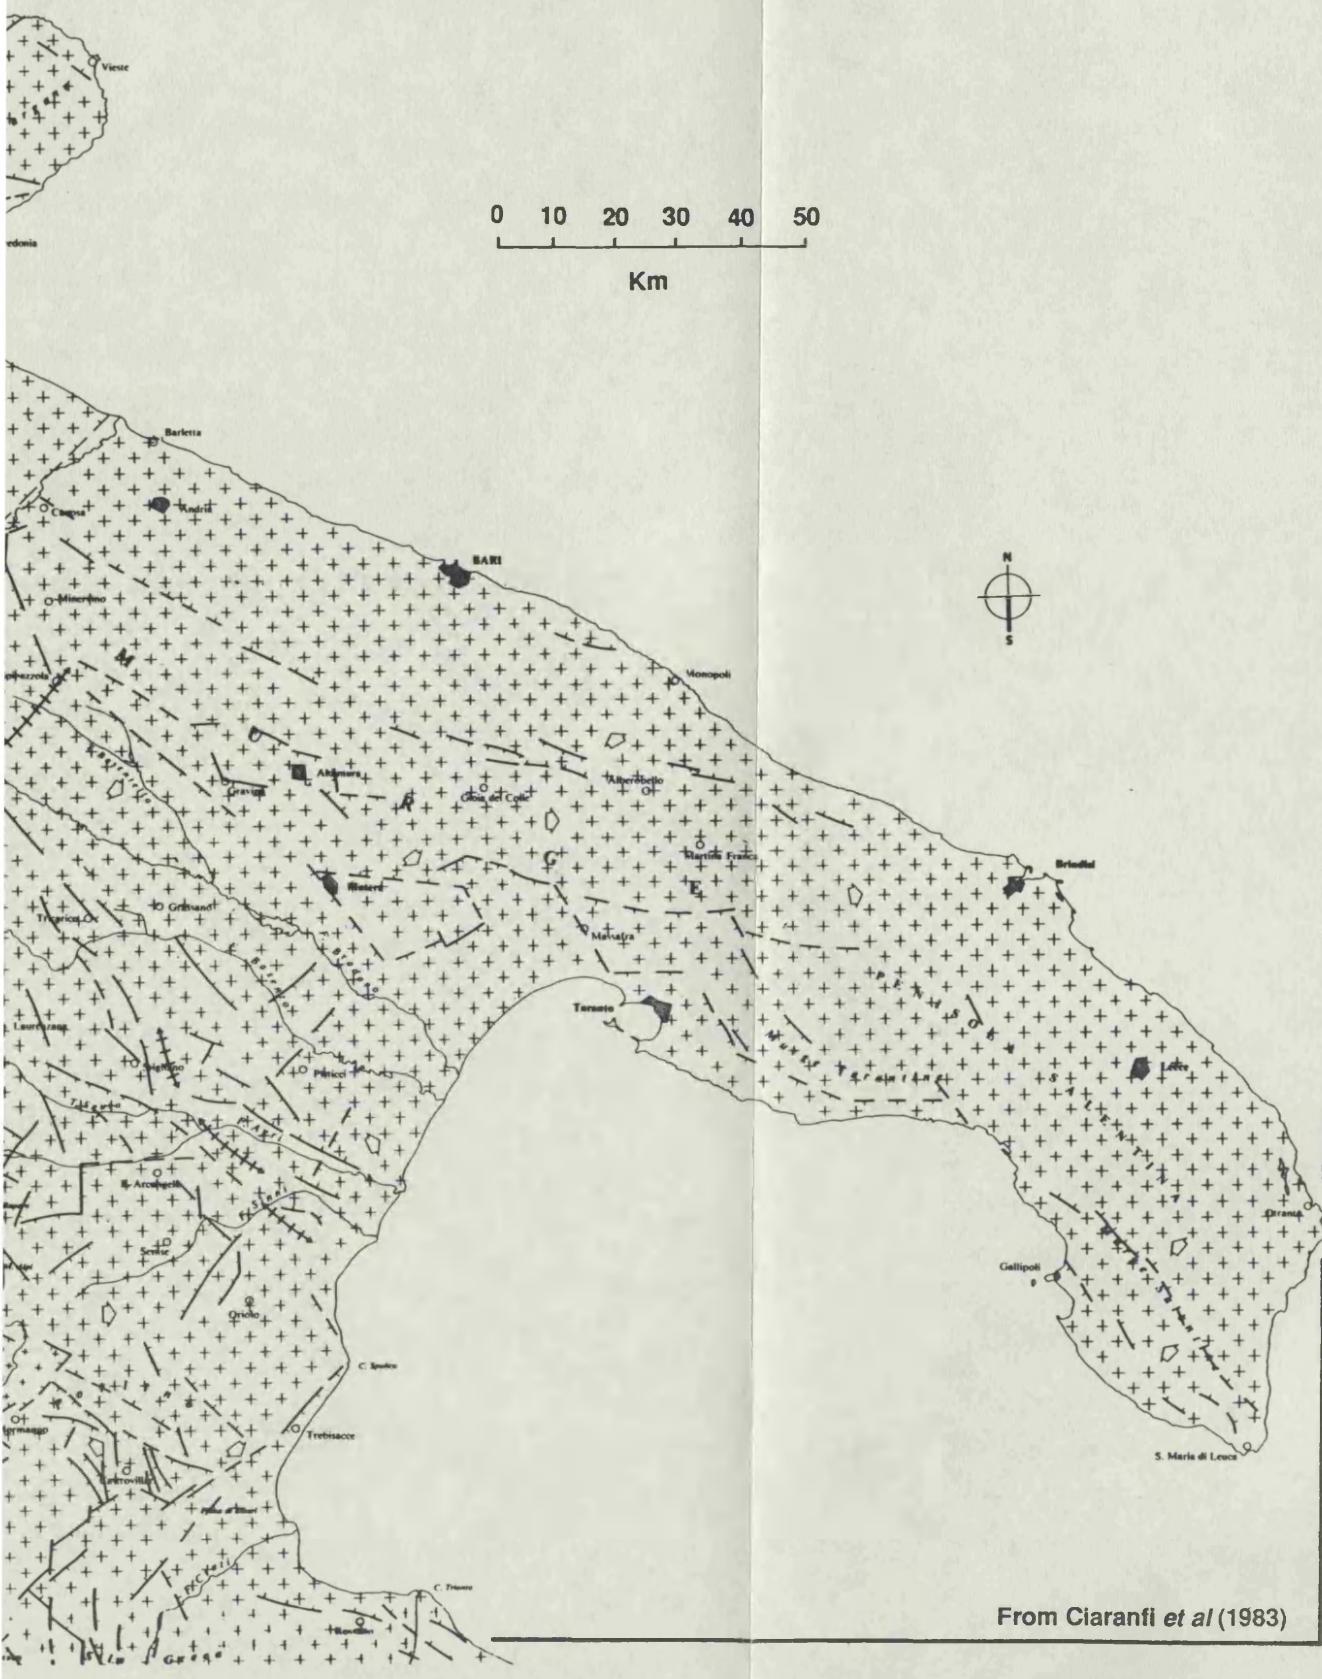
Fig. 2.5d: Neotectonic evolution of southern Italy - Interval IV - V

O.7MY - 0.018MY BP & 0.018 MY - Date

- **Interval IV - V (See Fig. 2.5d and Legend)**

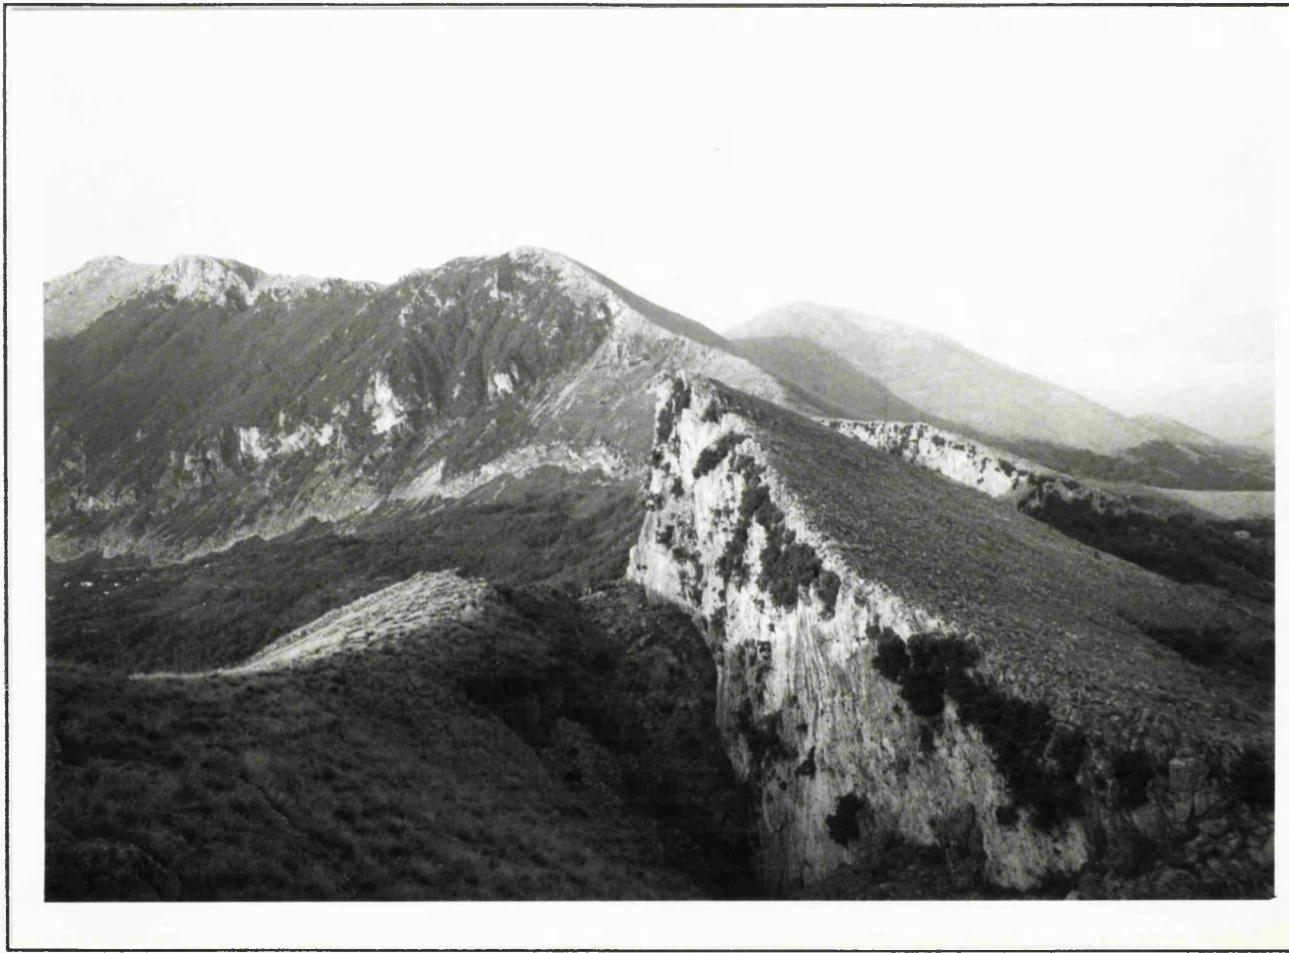
Plate 3.2: The sackung from the summit of Monte San Biagio, looking towards the Calabrian mountains. The break in the foreground is N2. The primary break (N1), leads from the fault plane scarp in the background.

its size and differing inclination. The other breaks have the following approximate maximum heights; N2, 20m; N3, 15m; N4, 10m; N5, 10m; N6, 5m; N7, 15m; N8, 5m; N9, 2m. It is possible that the break planes associated with these scarps join underground, although there is no evidence to confirm or refute this hypothesis.

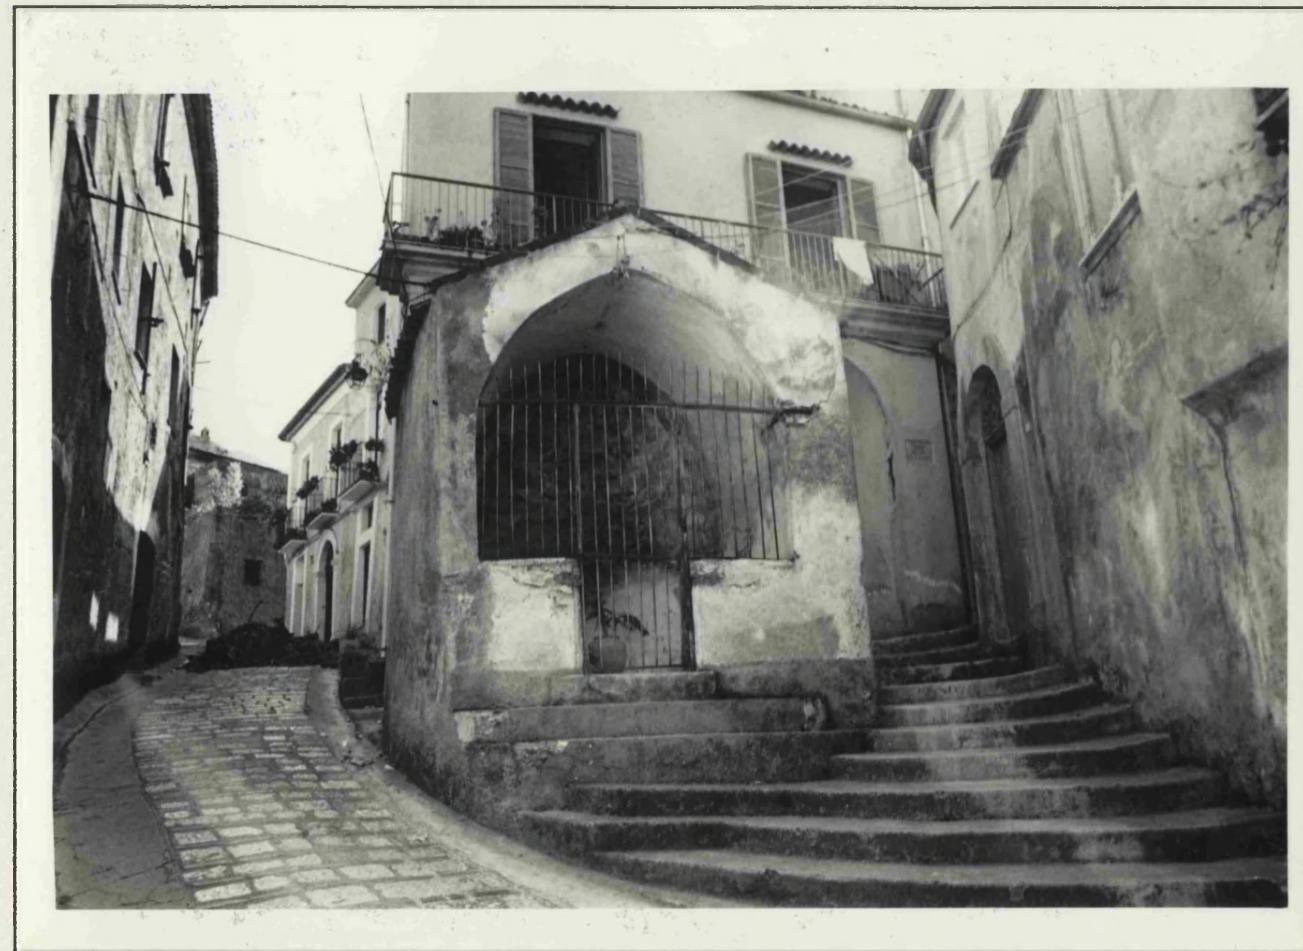
Plate 3.3: Small chapel in the *Via Pendinata*, thought to be the oldest building in Maratea. Dated to the 11th Century.

Renewed historical movements associated with the sackung (Guerricchio et al's, Phase D, 1987) are easier to date. The oldest building in the *centro storico* is a small chapel in the *Via Pendinata*, adjacent to the sackung, dated to the 11th century A.D. (Plate 3.3) From this time, until the present, the *centro storico* has experienced serious building damage, widely thought to be the consequence of a rejuvenation of the sackung (Guerricchio et al, 1987). For example, in the late 11th - early 12th centuries, the records of one of the main churches - the *Chiesa di San Vito* - detail repairs to the church thought to be the result of sackung movement. In 1500 the church records describe more damage and further repairs. The situation is repeated throughout the 15th century to the late 18th century, as more cracks appeared and further restoration was required, and persists to the present day. The *Chiesa di San Vito* now displays a distinct rotation of its altar relative to the main structure (Plate 3.4). A similar situation can be observed with the foremost church in Maratea - the *Chiesa di Santa Maria Maggiore* or *Chiesa Madre*, the 'Mother Church'. Here again a relative rotational movement of the altar stone is evident (Plate 3.5).

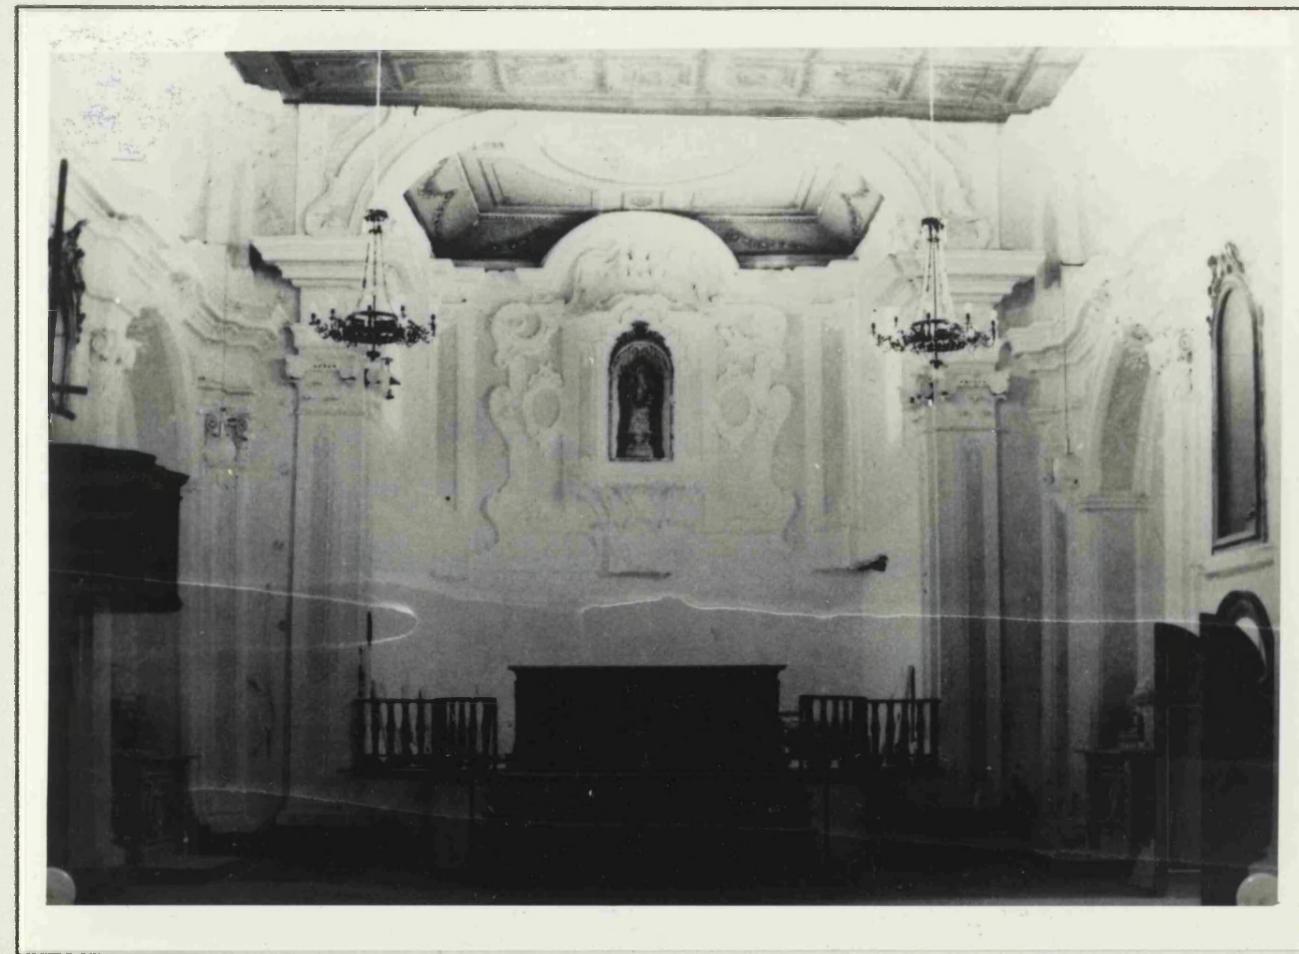
Plate 3.5: Interior of the Chiesa Santa Maria Maggiore - the altar is also thought to have rotated relative to the main structure. The church suffered severe damage during the 1982 earthquake. Photograph courtesy of Prof. V. Rizzo, CNR, Cosenza.

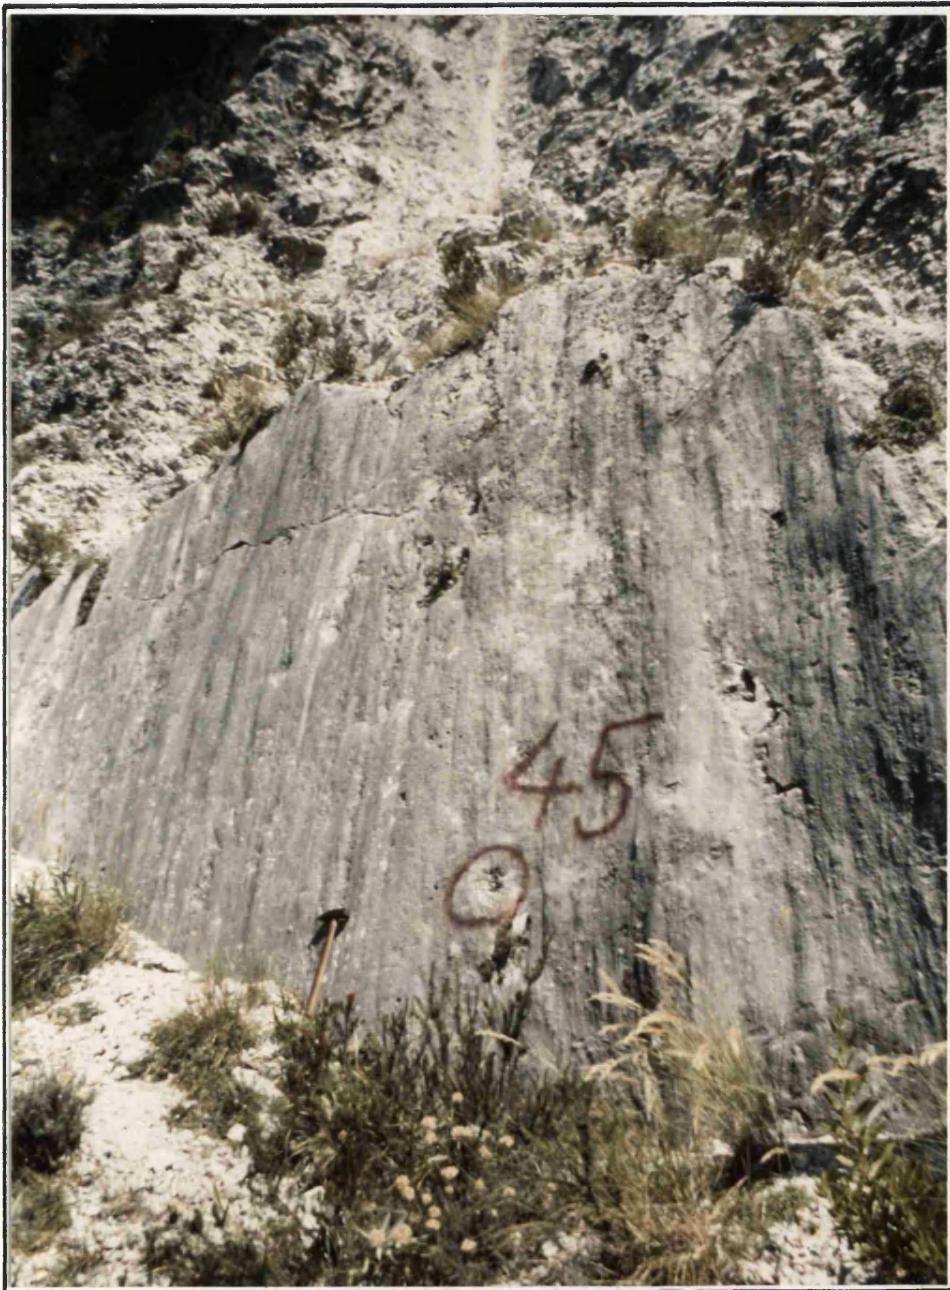
Plate 4.1: Survey marker pin 45. For location see fold-out map in back pocket.
