NEOTECTONICS, LANDSLIDES AND PLANNING:

The Case of Maratea (PZ),

Basilicata, Southern Italy

Thesis presented for the degree of Doctor of Philosophy

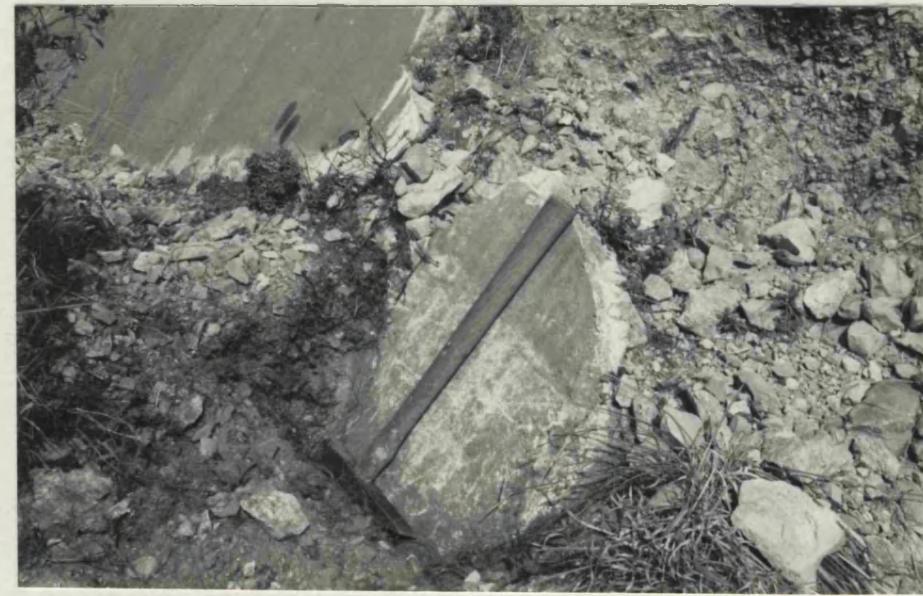
Plate 4.3a: Thick calcite layer embeded onto the fault plane scarp near Pin 65.

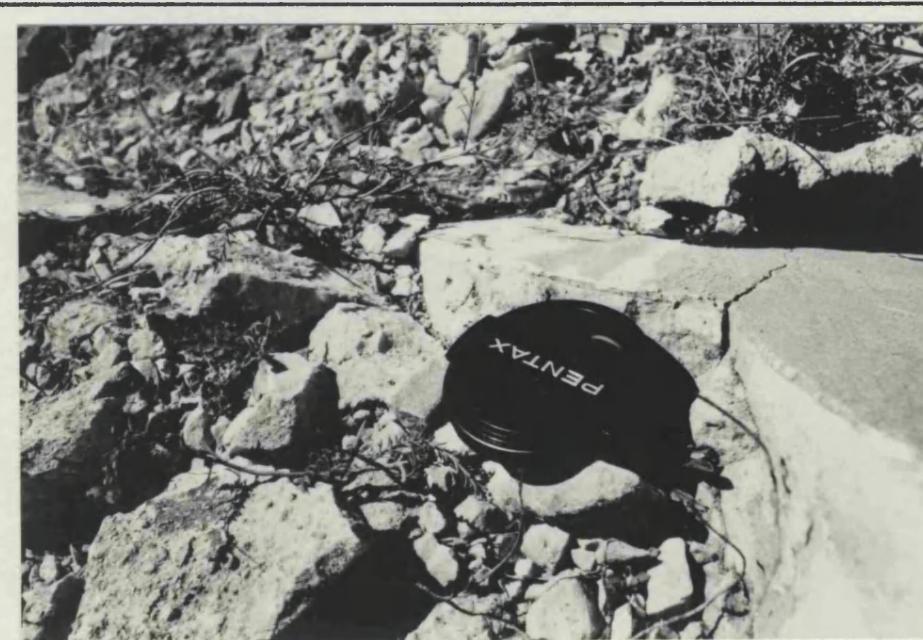
Plate 4.3b: Looking down onto the thick calcite layer near Pin 65. The material at the top of the photograph is the talus at the bottom of the fault plane scarp.

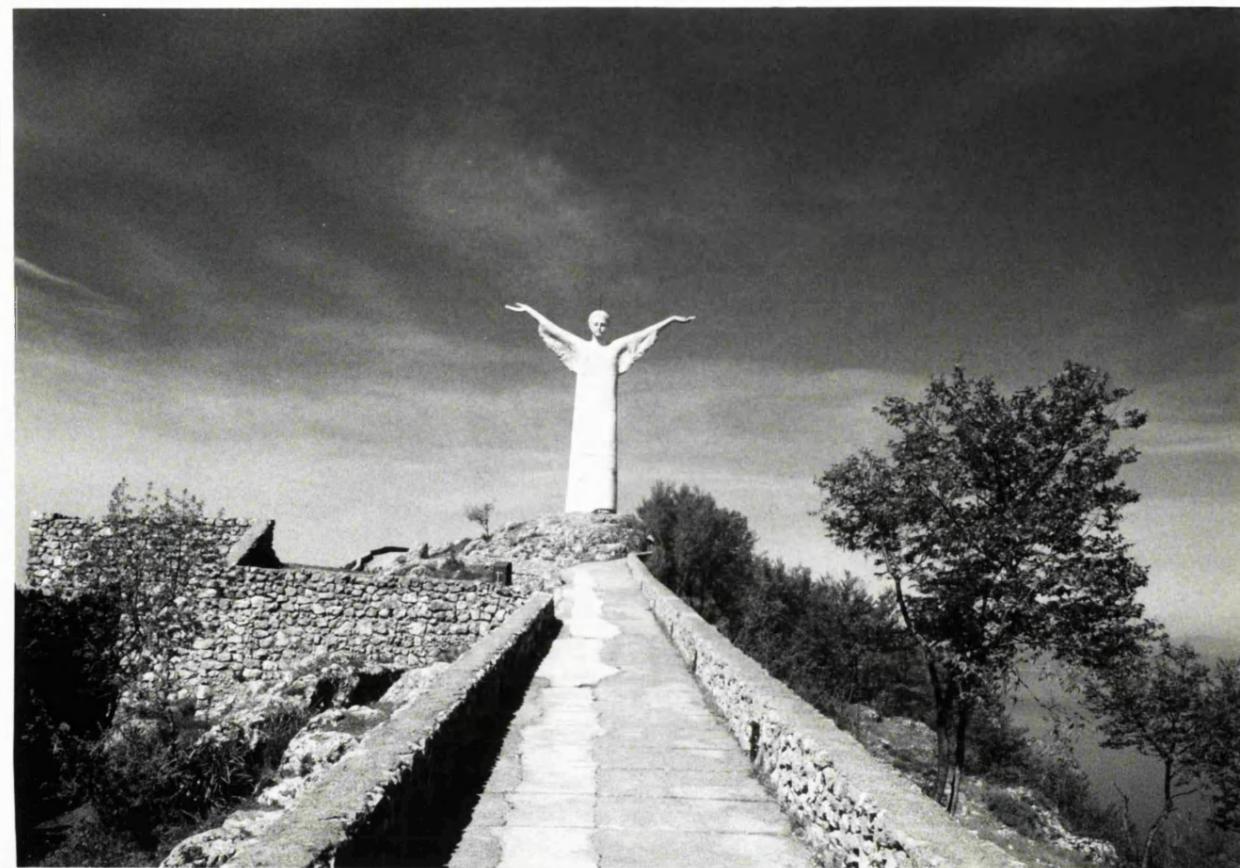
Plate 5.1: Substrate 1 - the road to the Statue of Christ constructed in 1978

One of the most impressive features of Maratea is the figure of Christ which stands on the summit of Monte San Biagio (Plate 5.1). The statue was constructed in 1963 of steel reinforced concrete. Being of a different material to the fault plane scarp, it is not itself a suitable substrate for lichenometric dating. However, in 1978 a footpath leading to the statue was constructed for visitors (Lamarca, 1986) and it is this which provides the datable substrate.

The path is flanked on either side by a wall (Plate 5.1), constructed of local limestone extracted from a quarry at Brefaro in the adjacent valley. The wall is constructed of small blocks about 150mm - 200mm square and lichens may be observed over its entire length. Most of the wall blocks have been 'faced', that is they have been shaped and squared off; this process exposes a fresh substrate for lichen colonisation. Lichen measurements were only taken on faced blocks; any block that appeared to have its original surface was not considered as it may have supported a lichen community dating from a period before the construction of the wall.

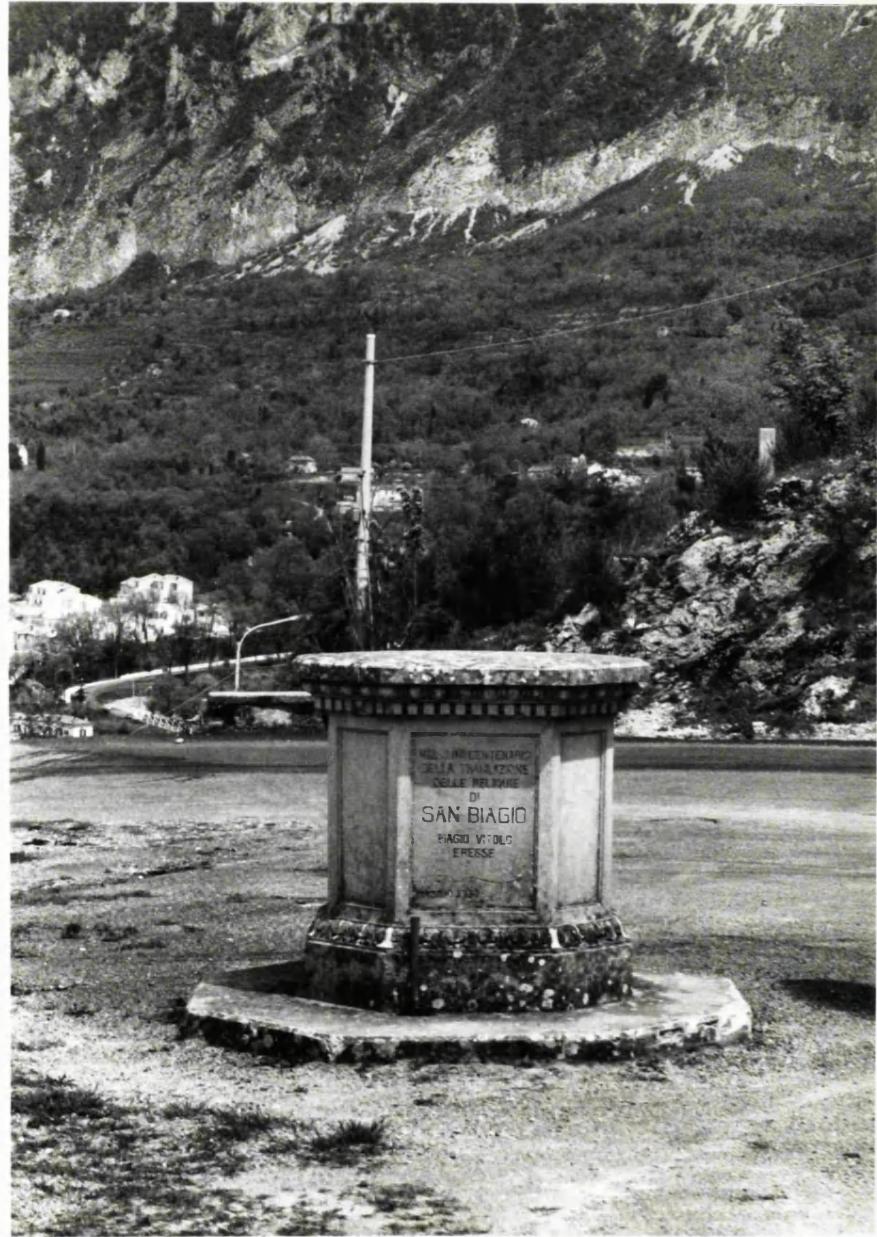
Plate 5.2: Substrate 6 - the memorial to San Biagio on the Capo Casale.
Note the heavy lichen colonisation on the top and base. The fault plane scarp can be seen in the background.

On the site of a small promontory known as the Capo Casale, just off the road that leads from the *centro storico* to the statue of Christ is a memorial to San Biagio, patron saint of Maratea. The memorial is in the form of a small podium about 1.5m high and was constructed in 1932 to mark the twelfth centenary of the transfer of the remains of the saint from Armenia to Maratea (Plate 5.2).

The memorial supports a healthy lichen community on its flat top and around the base (Plate 5.2). Photographic evidence (Lamarca, 1986) shows the memorial to be totally lichen free when it was constructed and to support a healthy lichen community in 1982. The podium has a shaped and faced octagonal body of granite with

a concrete base and capstone. The body is totally lichen free while the base and capstone support the lichen community. Officials from the Office of Public Works stated that there was no record of the stone having been cleaned.

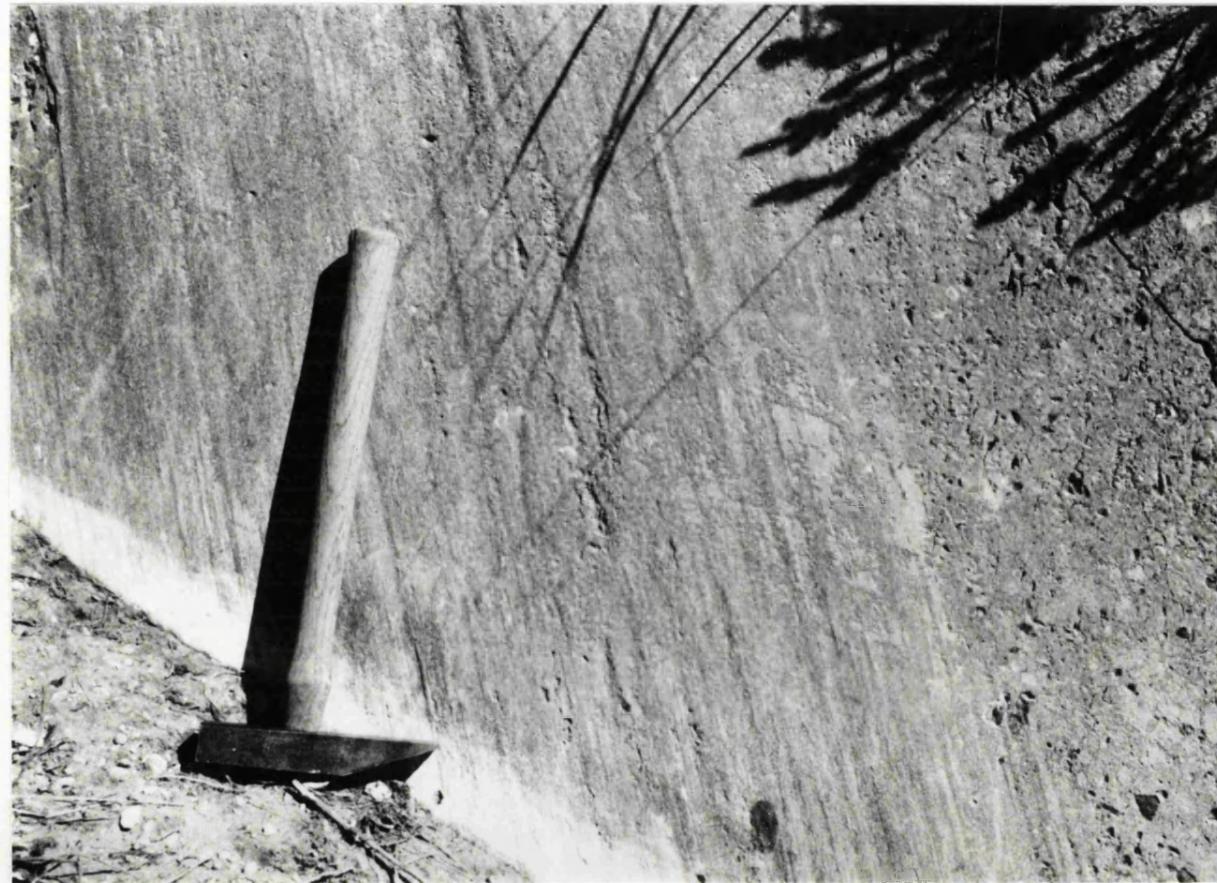
Plate 6.1: The "White Line" at the base of the fault plane scarp. A band of darker colouration can be seen above the white line indicating an earlier phase of movement.

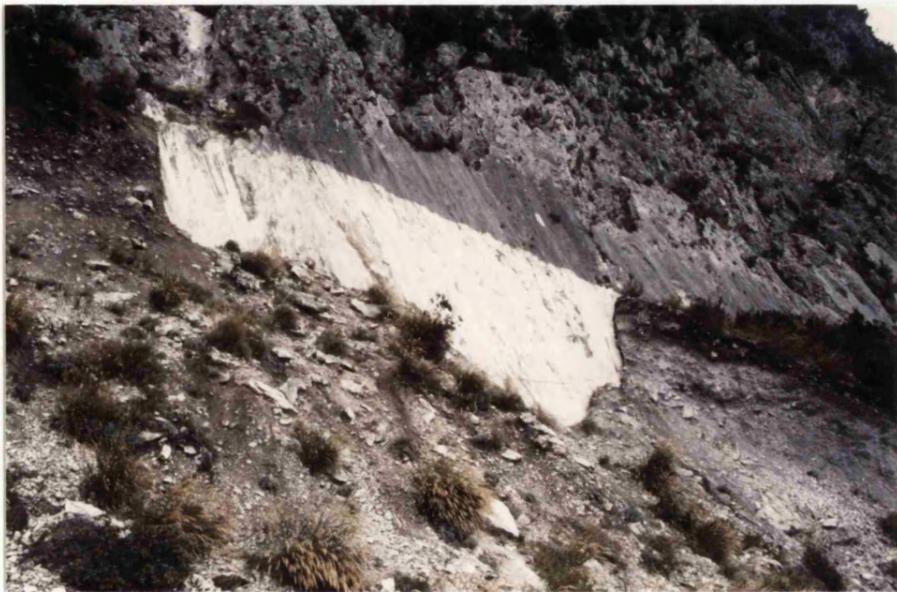
Plate 6.2: The difference between weathered and newly exposed fault plane scarp, most dramatically seen at the abandoned quarry near pin 53.

The importance of the 'white line' or "refreshening" is that it indicates relatively brief exposure due to recent movement (Plate 6.2), although the form of this movement is not known. In order to investigate the nature of these movements and the time scale over which they have occurred, the following investigations were carried out.

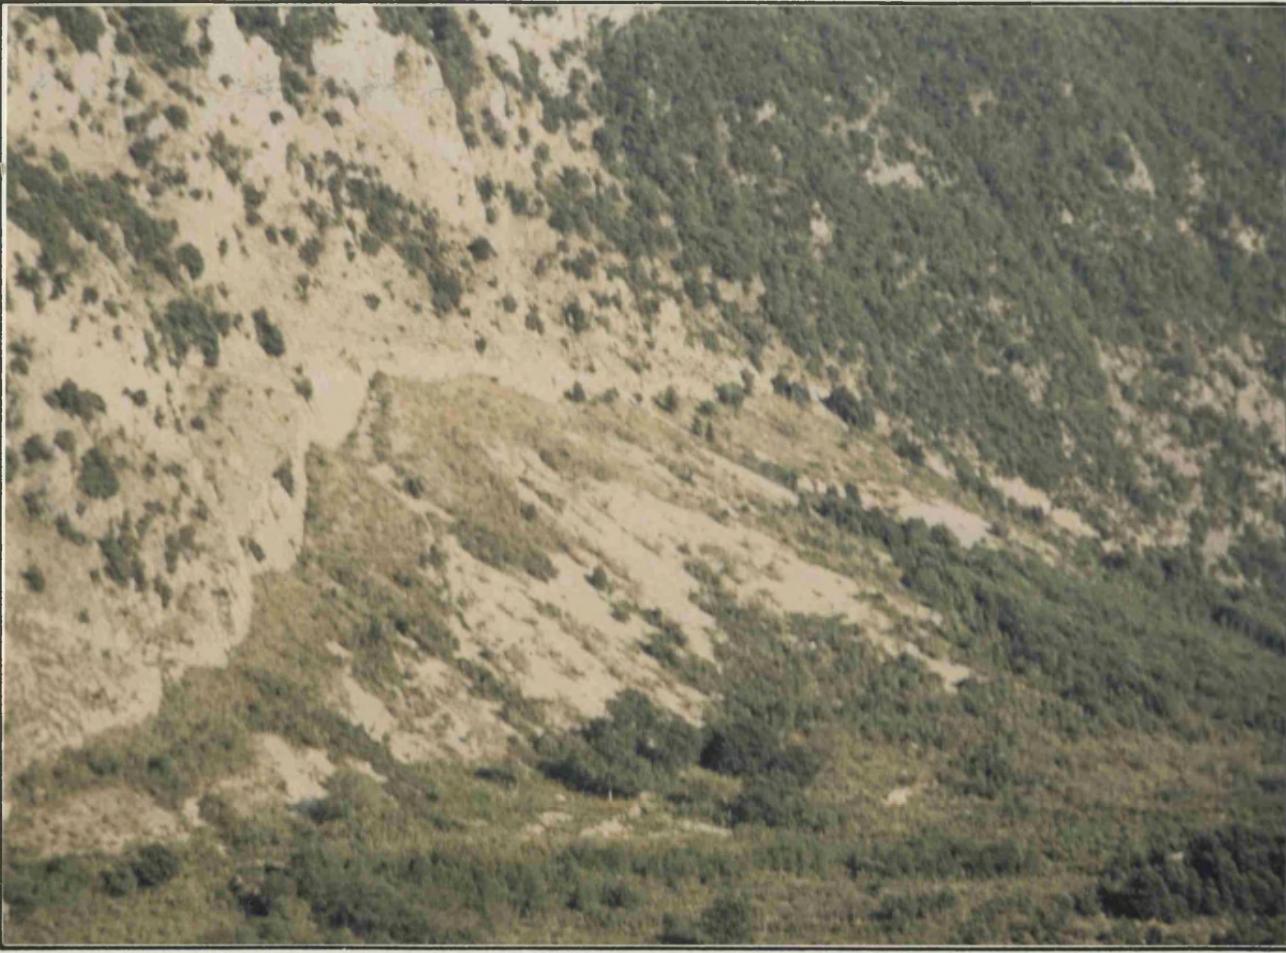
Plate 6.3: The major debris cone at the head of the valley. The three zones can be clearly seen in the photograph: the upper zone (Zone 1) nearest to the fault plane scarp is composed of vegetated talus; the middle zone (Zone 2) spans the middle third of the cone and is composed of less well vegetated talus, heavily dissected by boulder channels; Zone 3 is the heavily vegetated area at the base of the cone.

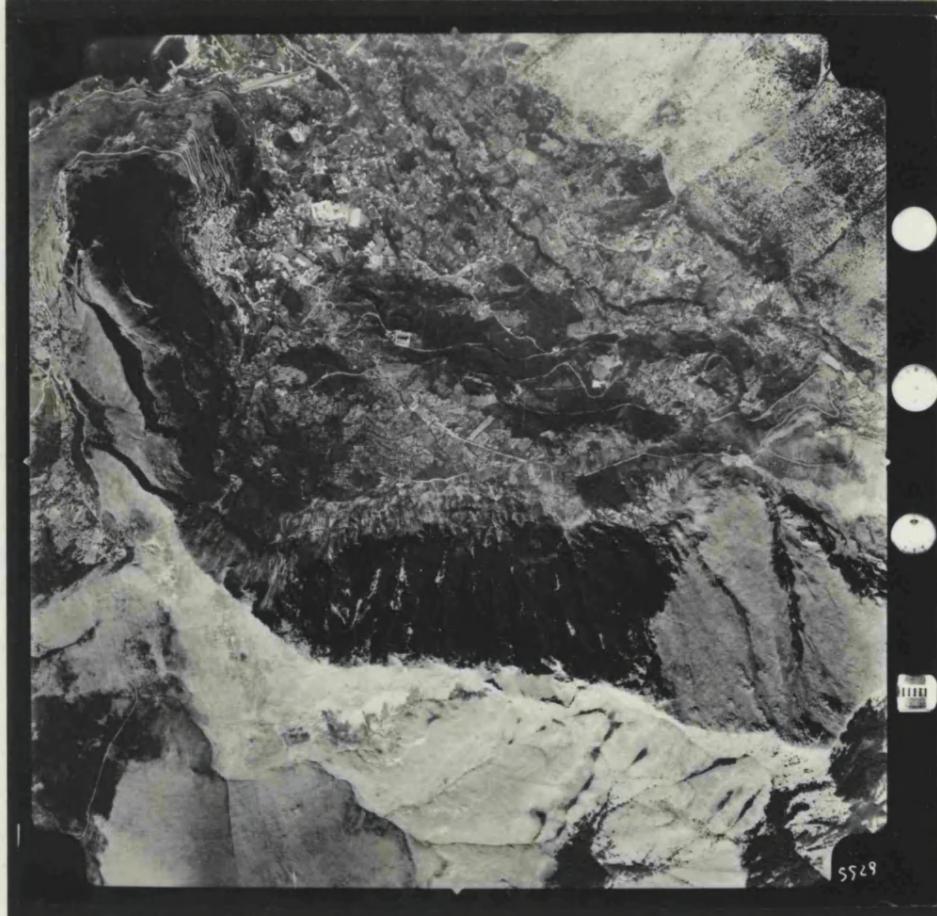
Plate 7.1: Aerial photograph of the Maratea Valley. The sackung is on the centre left (south) of the photograph with the fault line leading from the most southerly break. Running north - south through the centre of the photograph is the Maratea - Trecchina road which marks the base of the limestone blocks. Left and slightly up from the centre of the photograph is a light coloured square which is the Maratea cemetery - Block VA is to the south (left) of this. Photograph 46421 flown on 20 November 1974 - courtesy of the Istituto Geografico Militare, Florence.

The mapping programme was supplemented by an air-photographic analysis of the valley (see Plate 7.1 and stereo pair of photographs in the back pocket of this thesis)), beyond the confining boundaries of the geomorphological map itself. The air-photograph interpretation was carried out according to well accepted practice (for example, see, Cooke and Doornkamp, 1989; Doornkamp, 1984; Verstappen and Zuidam 1968, and for photographic interpretation of southern Italian landslide-prone area, Nossin, 1973). In the Maratea valley an air photograph interpretation

The basal concavity marks the line along which the blocks appear to be breaking up; westward of this line are found smaller blocks which seem to have broken away from the parent block. This situation is particularly evident in the case of Block V (see Plates 7.1 and 7.2). The road runs along the basal concavity of block V but almost along the top of V_A. Air photographs show continuity of the block across the road suggesting that blocks V and V_A were once part of the same feature and that V_A has both split away from, and sunk, relative to the parent block.

Block V_A (see Fig 7.4 and Plates 7.1 and 7.2) is the only block to show clear signs of recent movement. In section 7.1 it was noted that V_A is probably a fragment of Block V, which has broken away from the parent block and sunk relative to it. A spring line at the base of Block V has caused a small stream to flow over the top of Block V_A, mobilised the calcium carbonate within the limestone and redeposited it as stalactitic tufa over the leading edge of Block V_A (Plate 7.3). Sections taken by the author through stalactites from Block V_A show several phases of stalactite growth around different growth axes indicating possible movements of the block during the growth of the stalactites. This observation indicates a basis for dating each of the growth phases and consequently charting the movement of the block.

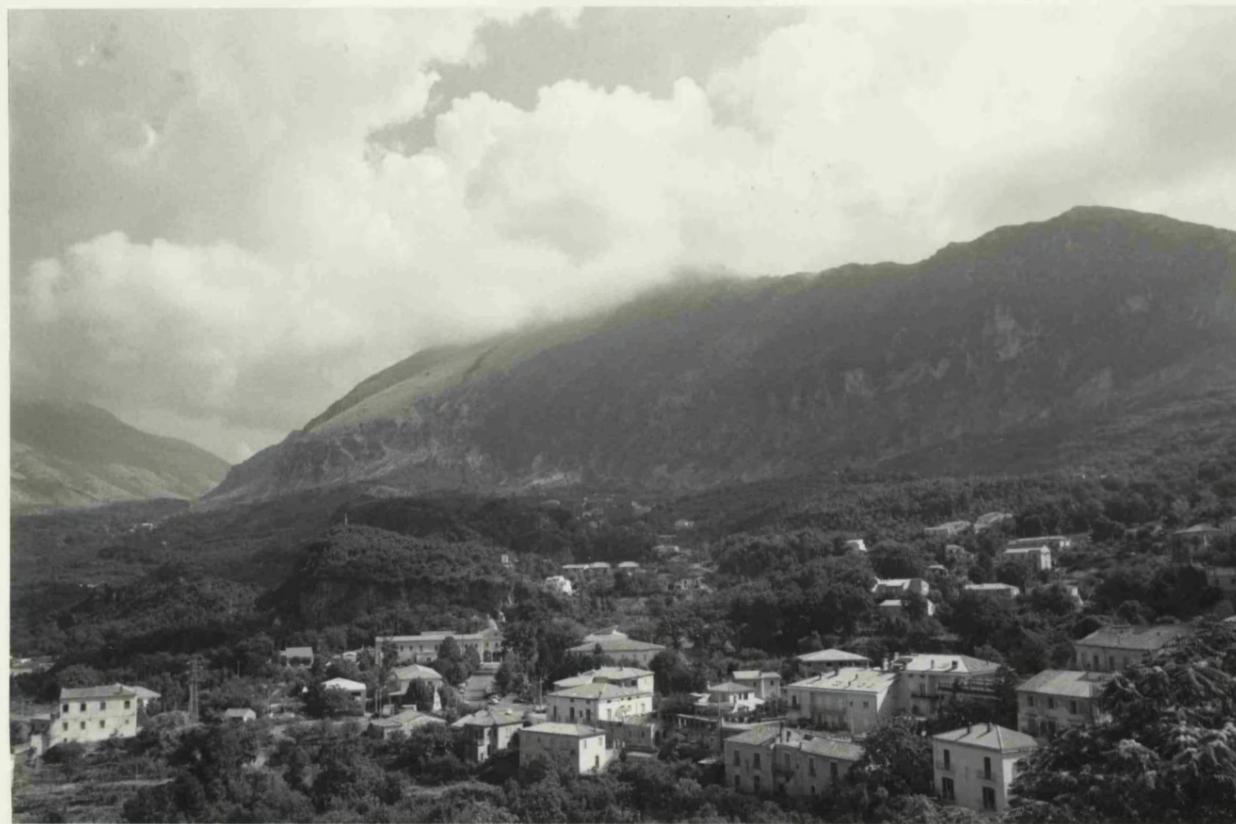
Plate 7.2: The limestone blocks in the valley floor - Block VA can be seen in the foreground.

A combination of the geomorphological map and air-photograph interpretation revealed the presence of six limestone blocks (Plate 7.2). Four were situated in the area of the geomorphological map (see Fig. 7.1, blocks I - IV) and one immediately outside its south-west boundary (block V, see Fig. 7.2). These five blocks were adjacent to talus slopes beneath the fault scarp. A sixth block (block VI) was identified near the coast at the Porto di Maratea (Fig. 7.2). In the case of the five blocks adjacent to the talus, a common and diagnostic feature is a marked concave break of slope at the base of the talus. Blocks II and III shown on the geomorphological map have a track cut into this concavity. Talus angles immediately eastward of the break of slope are in the order of 23° - 25° , although the central section of the map (approximately between pins 45 - 68) has been heavily remodelled by ploughing for agriculture. A more accurate picture is, therefore, seen with the example of Block IV; here talus angles east of the break of slope are in the range 26° - 28° , indeed a small talus cone (seen on Fig. 7.1 above the legend 'rough pasture'), is bisected by the concavity and the path. Westwards of the concavity there is either level ground (noted on Block III) or a reverse angle of 2° - 3° trending back towards the fault scarp (Blocks II and IV). The leading edge of the blocks is usually marked by a clear convex break of slope with slope angles in the range 60° - 70° . The cross sectional form of the blocks can be seen in Fig. 7.3. It can thus be seen that the limestone blocks may be accurately described as blocks rather than mounds of debris or talus. In the area of the geomorphological map they all have a definable and clear rear boundary, a flat or back-sloping top and a steep front edge leading to a definite base.

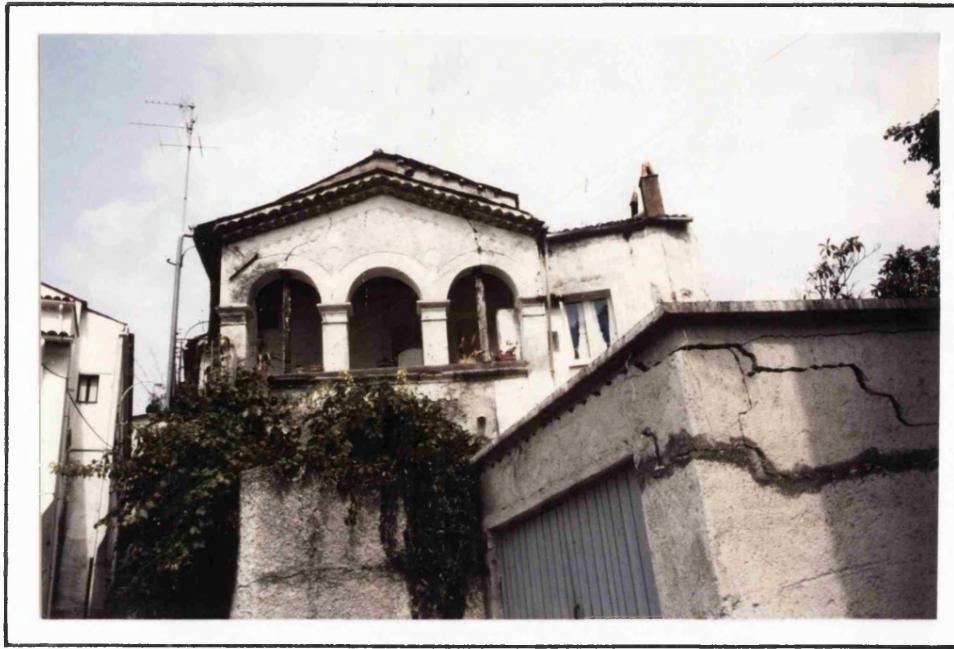
Plate 9.2: Building FG3/163 at the top of the Via Pendinata in the *centro storico*. The building is seriously damaged (Grade 5), with timber props supporting the balcony arches, yet is still inhabited.

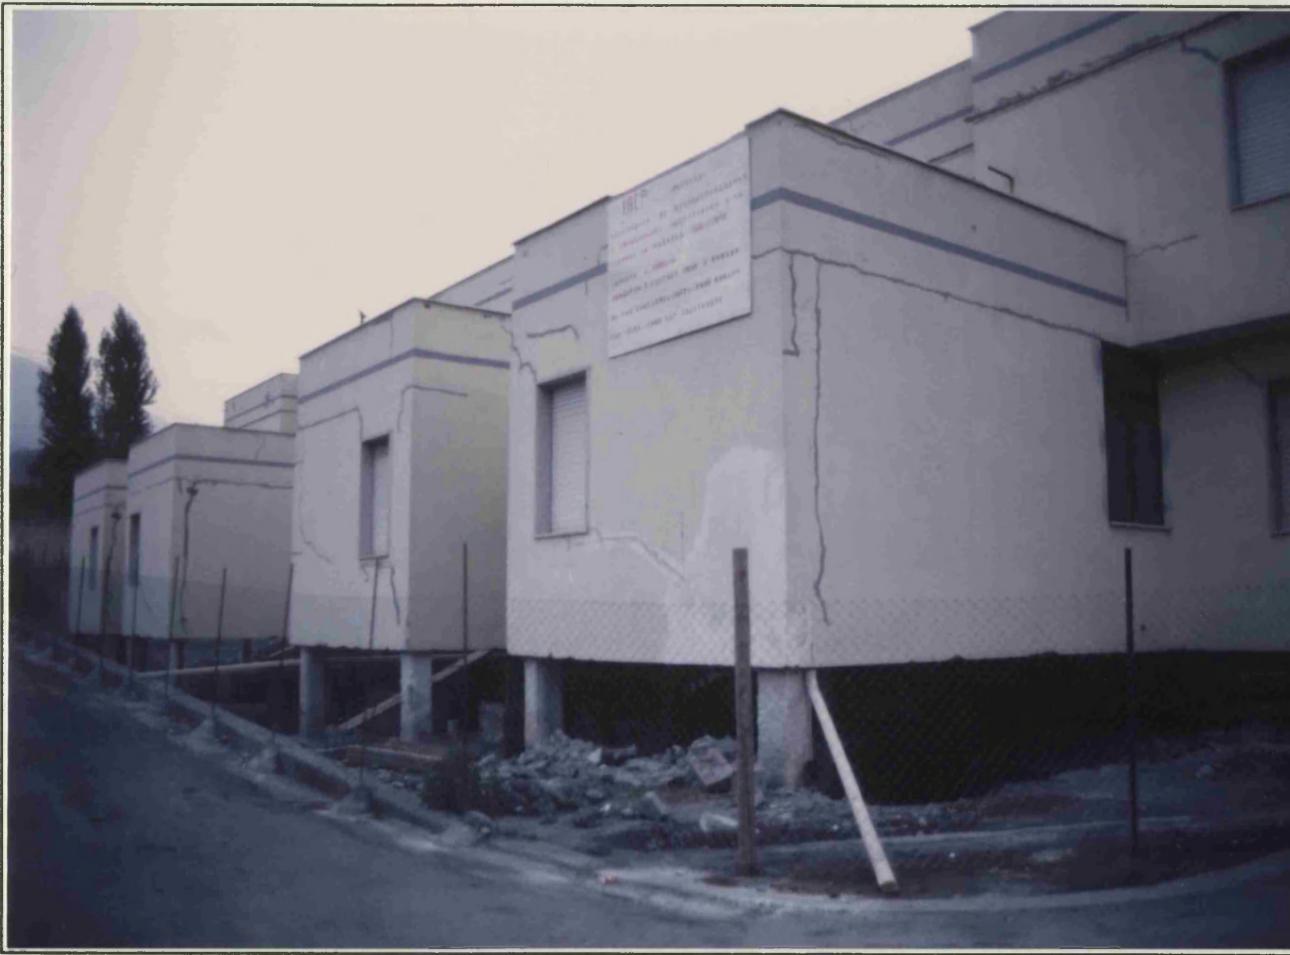
Plate 9.4: Buildings FG4/119 - FG4/121. Constructed in the 1970's, only extensive underpinning has saved these buildings from demolition.
